The LONDON MIDLAND and SCOTTISH RAILWAY

FOUNDED 1963

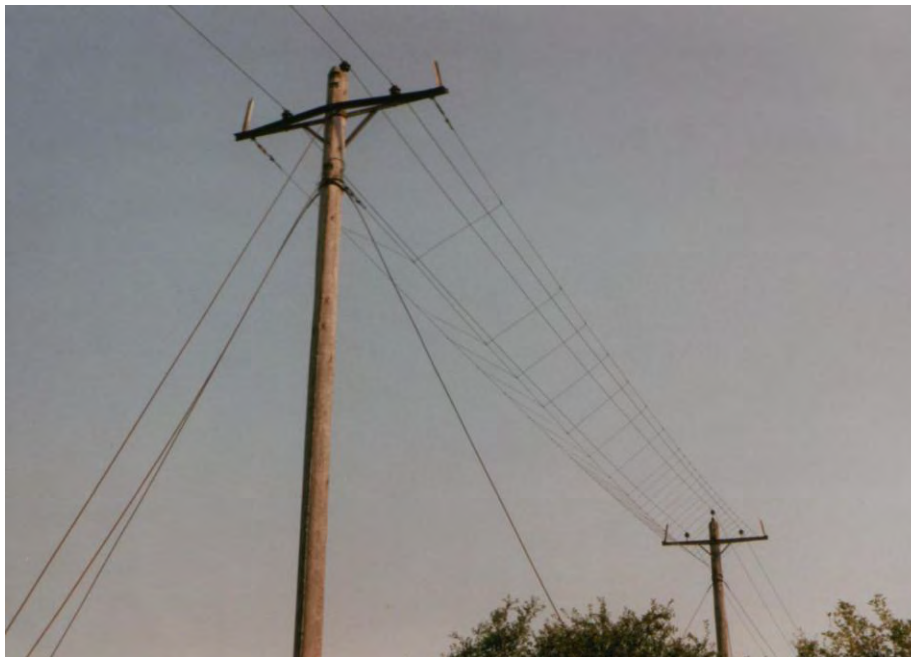
A SWEB constructed railway cradle to Drawing SCGA 2/15 at Huntworth near Bridgwater using 46 foot long poles of 1957 vintage with 0.10sq. inch conductors on pin type insulators and earthed as the stays are plain with no insulators. With pin type insulators a catchment bracket is required at the end of the crossarms to prevent a conductor from slipping off the crossarm should the binding of the conductor to the pin insulator fail. Such an
